TESTING OF
COMBUSTIBLES ON THE HEATER HOUSINGS
USED IN ELECTRIC CLOTHES DRYERS

TESTING OF COMBUSTIBLES ON THE HEATER HOUSINGS USED IN ELECTRIC CLOTHES DRYERS

JULY 2004

Division of Electrical Engineering
Directorate for Engineering Sciences

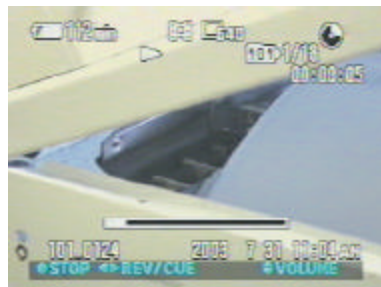
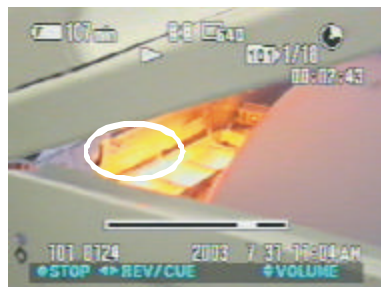
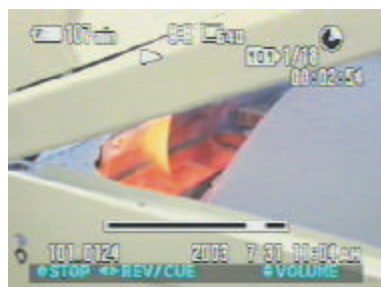
Figure 4. The cheesecloth ignited approximately 158 seconds after the dryer was started with the one-shot bypassed. The circle in frame 2 indicates where flames were first noticed.

Figure 4 shows photos of cheesecloth ignition during the second test of Dryer Design C. Ignition occurred at the rear of the heater housing.

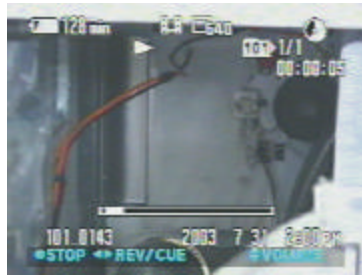
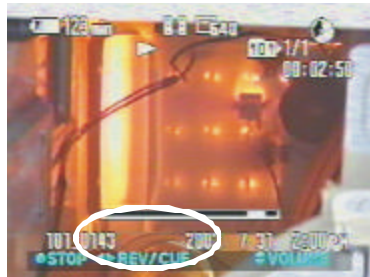
Figure 7. The cheesecloth ignited approximately 174 seconds after the dryer was started with the one-shot bypassed. The circle in frame 2 indicates where flames were first noticed.

Figure 7 shows when the cheesecloth ignited during the third test. The camera was oriented 90 degrees counterclockwise of the dryer. The figure shows the dryer oriented with the bottom of the dryer on the left and the top of the dryer to the right. Ignition occurred on the rear side of the heater housing.
